SAUNATEC Sauna Service Sheet –

Club Name: Killamarsh sports centre, Stanley Street, Sheffield, S21 1EL

Visit 6-2-2020

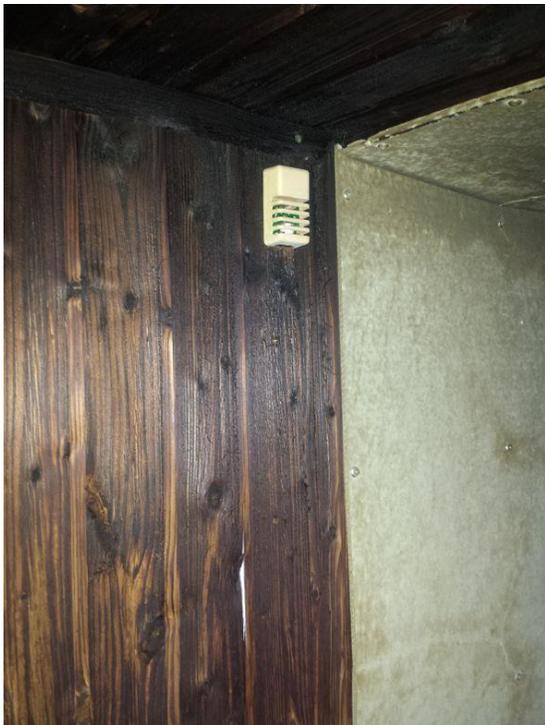
Internal lining Damaged and scorched

Your Sauna is now 20 years old. Commercial saunas will deteriorate over time depending on usage. Average commercial sauna will be heated for 14 hrs a day this will eventually damage the internal lining and the structural frame. At 10 years then refurbishment would be an option however at 20 years the sauna is a Fire Hazard and will be best to remove and replace with new.

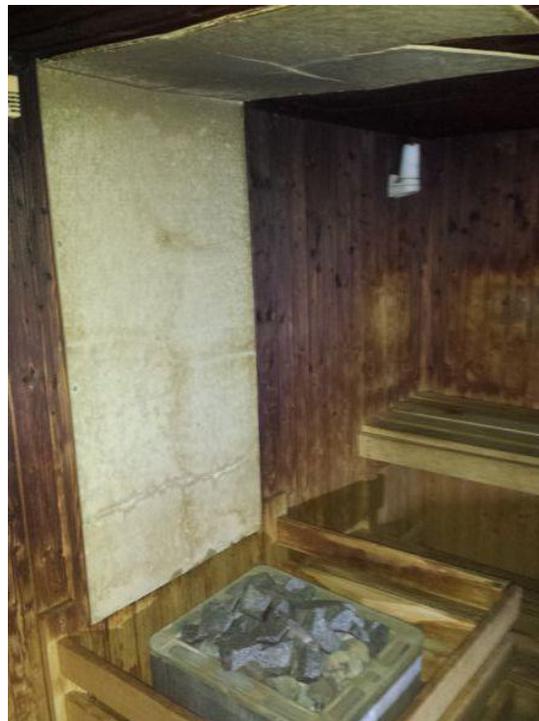
Heat proof lining Damaged Heater in poor condition.

Replacement Sauna will be the best option. I suggest that the new sauna is slightly smaller at 2.5 mt x 2.5 mt x 2 mt high, this will cost less to run and be more suited to your needs. Optional energy saving technology can be incorporated into the new Design. If the Emotec D digital controller is used then Eco setting can be selected so the sauna will reduce heat to stand by temperature in low bather demand and can be busted for a set period for sauna bathers outside peak bathing times. The display control can be fitted at reception desk and Staff can monitor Sauna bathing times and boost control.

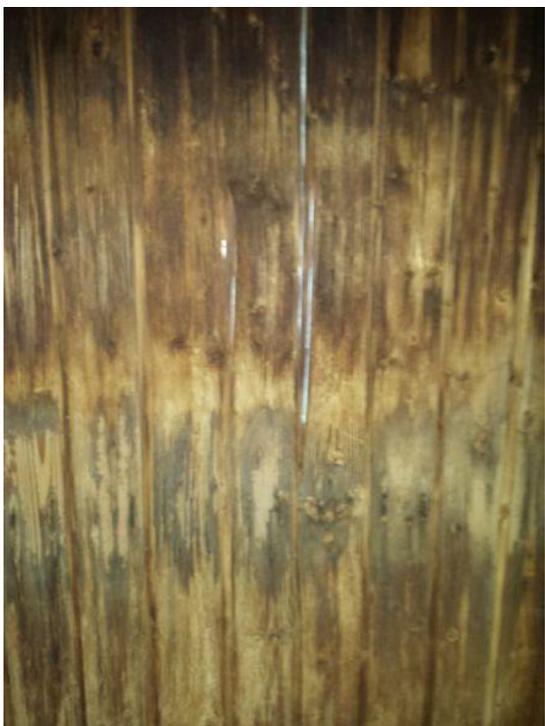
Spruce lining shrunk and damaged.

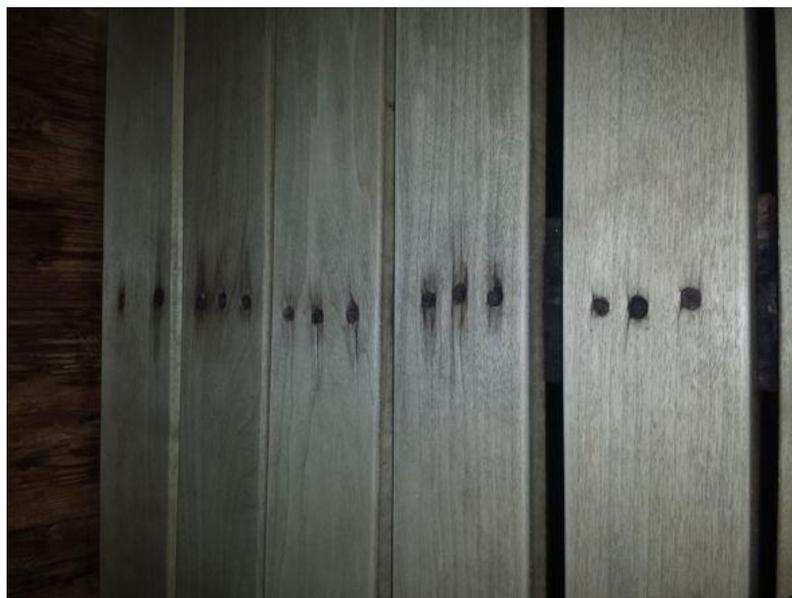
Benches beyond repair poor finish with exposed Rusty steel screws.

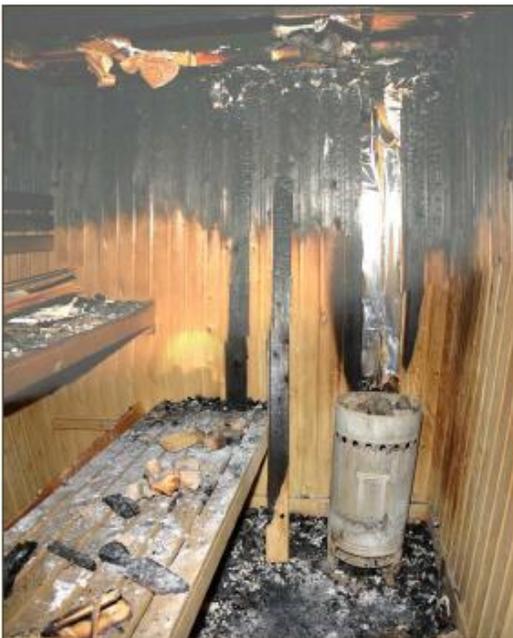
From time to time investigators from Burgoynes have been called upon to investigate the causes of fires that have occurred within sauna cubicles. Such fires, occurring as they do in sauna compartments that are timber-lined, are prone to develop rapidly and often cause substantial damage. Where such cubicles are located in leisure complexes or hotels the fires can lead to substantial economic loss. Several guidance documents have been produced^{1,2,3,4} relating to the installation and operation of saunas and an European Standard (BS-EN 60335-2-53) exists to provide manufacturers and installers with guidance relating to the design and construction of such equipment.
